Case 351 : Narrative

Case Vehicle (A): 2002 Ford	Vehicle (B): 2002 Ford	Vehicle (C): 1998 Chevrolet
Type: F150 XL Sport, 2-door 4x4 pickup	Type: Ranger Supercab, 4-door pickup	Type: GMT 400, 4x2 2-door truck
Driver: 30-year-old male	Driver: 23-year-old male	Driver: 45-year-old male
CDC: 12-RYES-1, 12-RBES-1, 12-FDEW-5	CDC: 99-0000-0	CDC: 99-0000-0

CASE NO.: 351-02

CASE VEHICLE: 2002 Ford

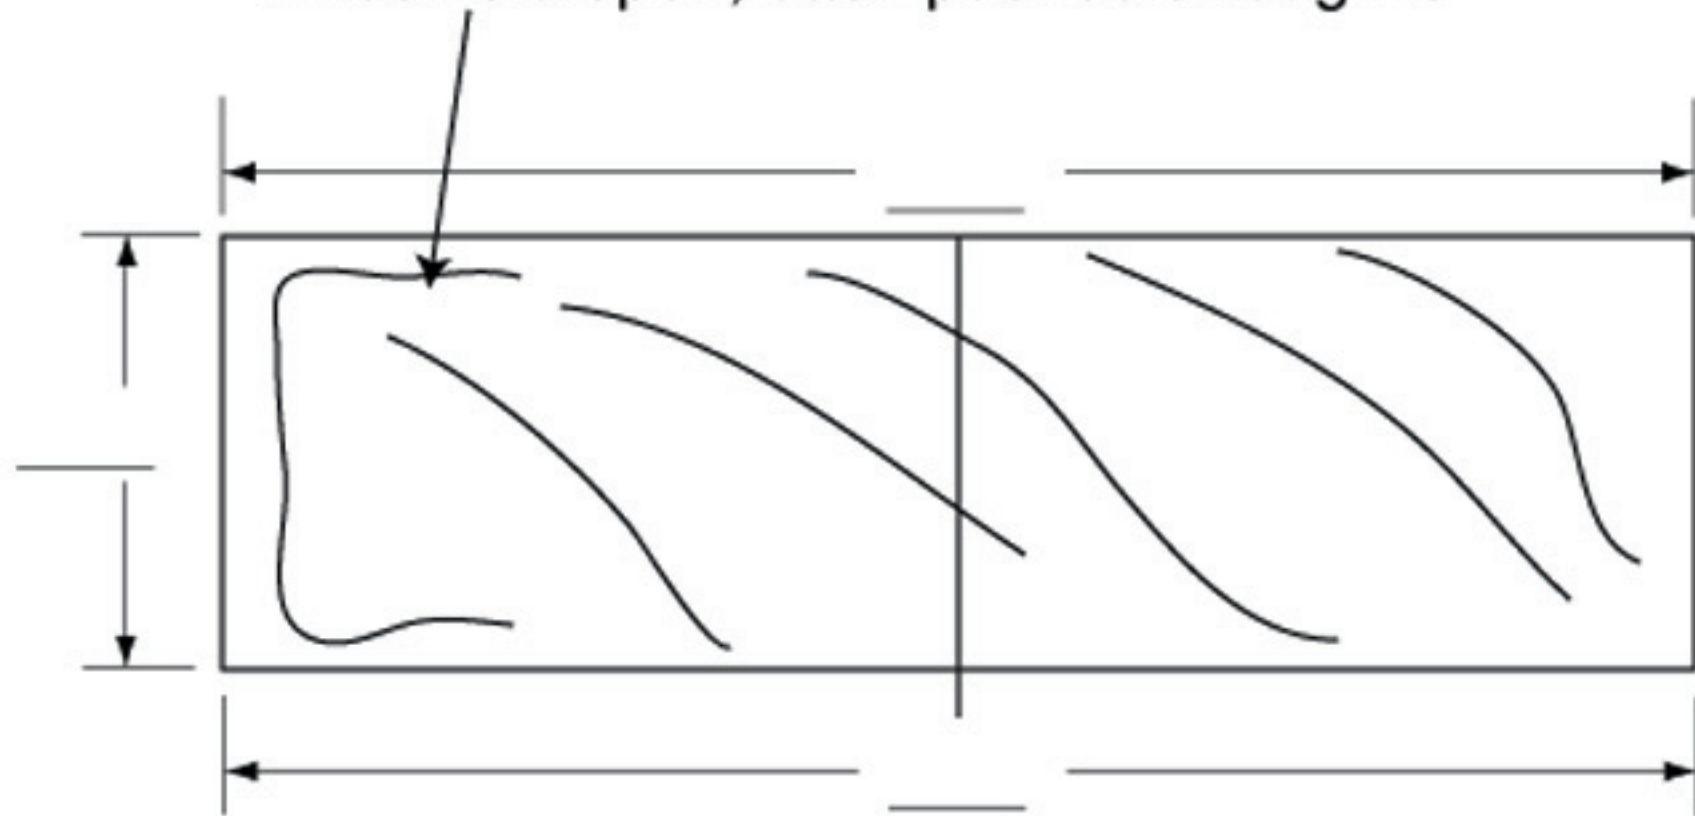
WINDSHIELD MARK ON CASE VEHICLE:

Unknown

windshield open, dash pushed through it

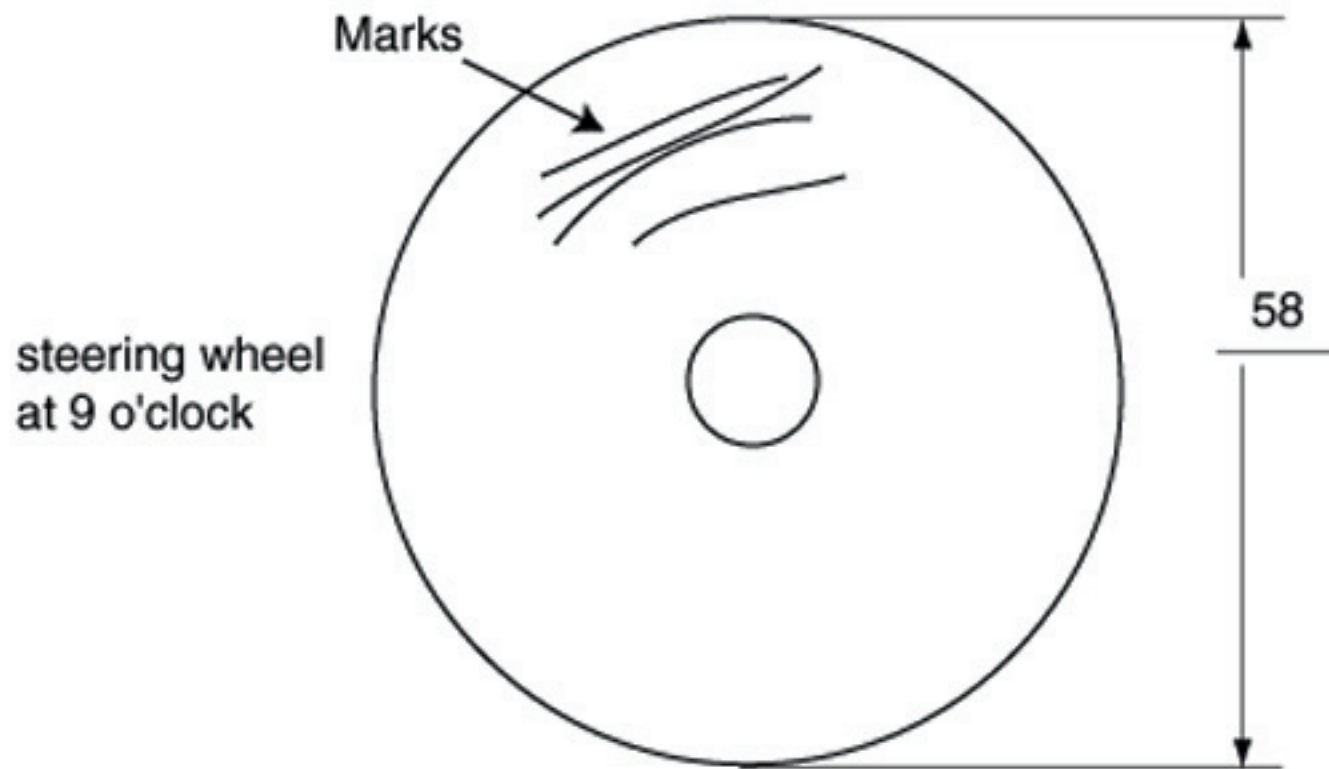
Driver Airbag

Vents: ☒ Y ☐ N
if yes, how many: 2

Tethers: ☒ Y ☐ N
if yes, how many: 1
